Town of Norton, Massachusetts

Energy Reduction Plan

Building Envelope Inspection Report

BUILDING ENCLOSURE RETROCOMMISSIONING

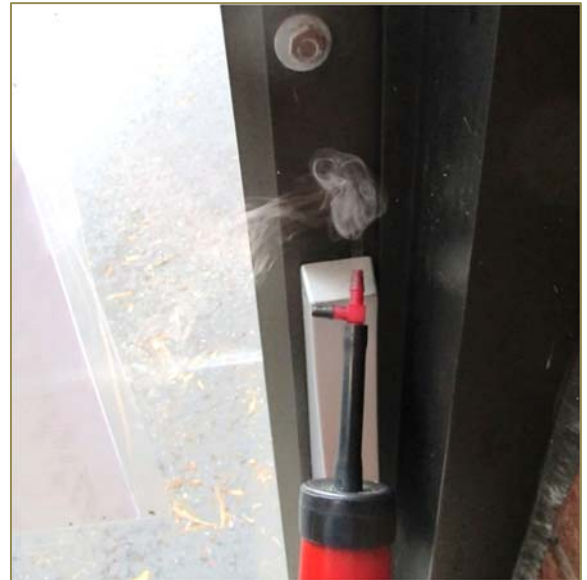
Right: Town Hall – tracer smoke testing along an exterior door. Note the smoke being blown back into the building, indicating the door system is very leaky, due to failing, deteriorated weatherstrip. Each of the exterior doors need to have new, effective weatherstrip installed.

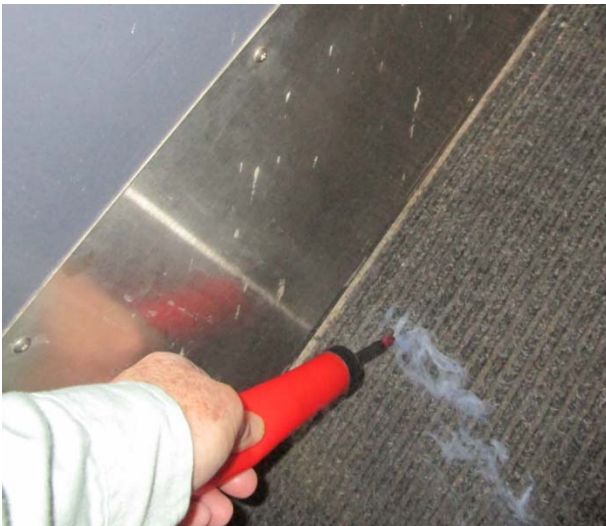
Left: High School – tracer smoke test being performed on exterior door system. The smoke being blown back into the building along the bottom of the door indicates the sweep weatherstrip is failing, allowing significant air, moisture, insect, and pollutant infiltration through the building envelope. The leakage along all sides of each exterior door is one source of the drafts and cold spots cited in occupant complaints. New weatherstrip needs to be installed.

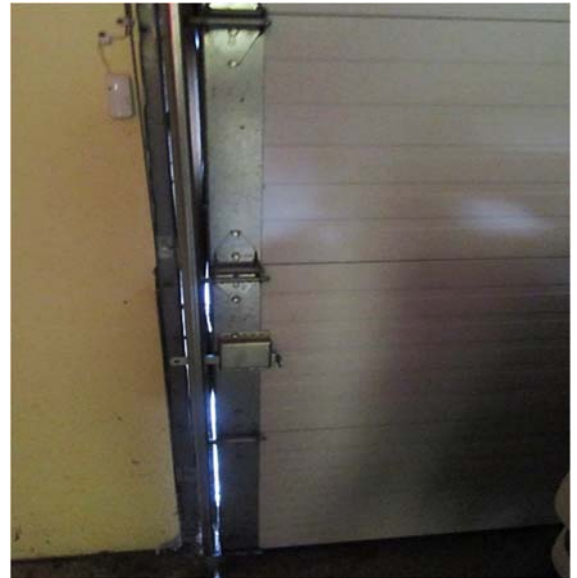
Right: Nourse E.S. – photo shows large gaps along the perimeter of the sectional overhead door. Note the daylight between the door and frame/weatherstrip! The failing/deteriorated weatherstrip needs to be replaced with new, effective, and durable weatherstrip.

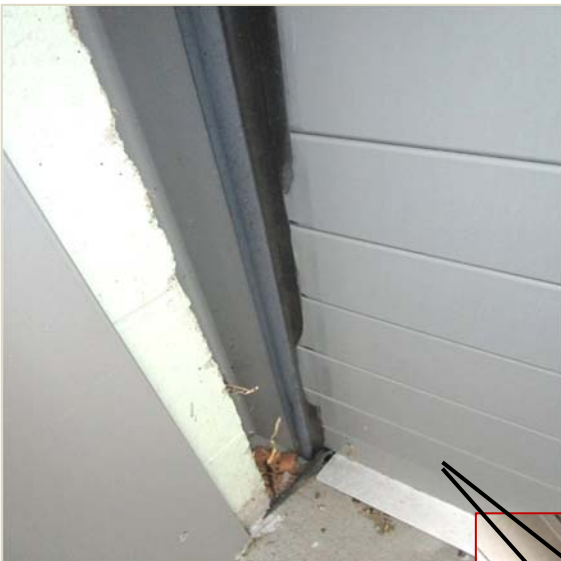
Left: Norton H.S. – photo shows the considerably deteriorated weatherstrip, with a large gap at the top as well, due to missing weatherstrip. New, appropriate weatherstrip needs to be installed along all sides of the door system.

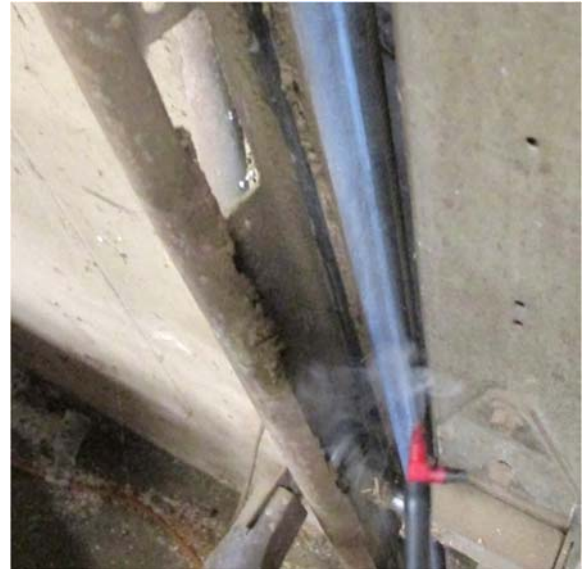
Right: Highway Dept – testing of the overhead doors in the heated high bay indicates a huge amount of air leakage, attributed to the lack of any effective weatherstrip on the door systems! Appropriate weatherstrip needs to be installed on each of the overhead doors within the heated high bay section to tighten the air leakage pathway through the building envelope, which will greatly improve the working environment for its occupants.

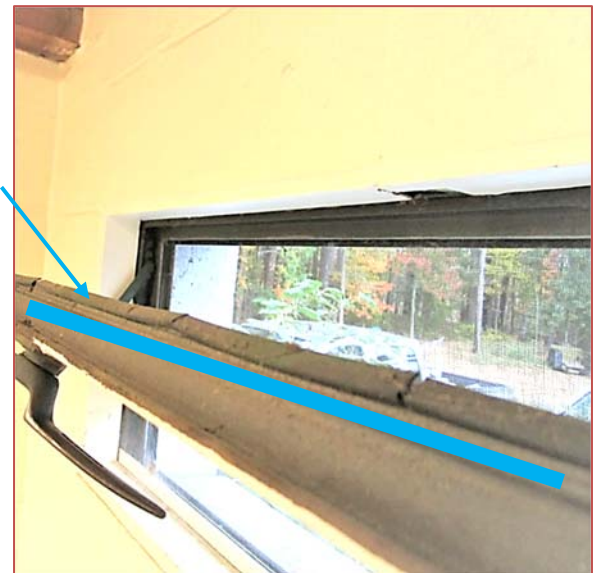
Right: Highway Dept. – the hopper and casement-type windows tested leaky along the sashes, attributed to the failure of the old, deteriorated weatherstrip. New, appropriate weatherstrip needs to be installed on each of the windows. Many of the windows also tested leaky along the framing and need to be air-sealed along the frame-wall junctures.

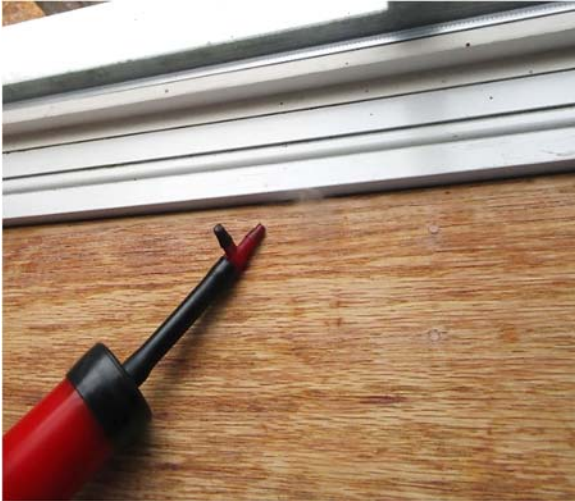
Left: Library – each of the windows tested leaky along the frame-wall junctures, attributed to missing sealants. These junctures need to be air-sealed on all sides using non-foam sealants.

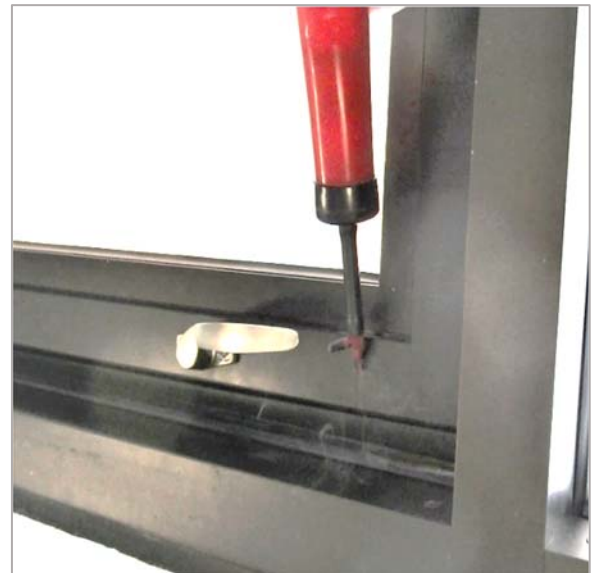
Right: Town Hall & Fire – most of the windows tested leaky along the sashes and glazing. The casement and awning windows need new, appropriate weatherstrip installed. Most of the units also need to be wet glazed, some along the interior and many along the exterior using non-foam sealants.

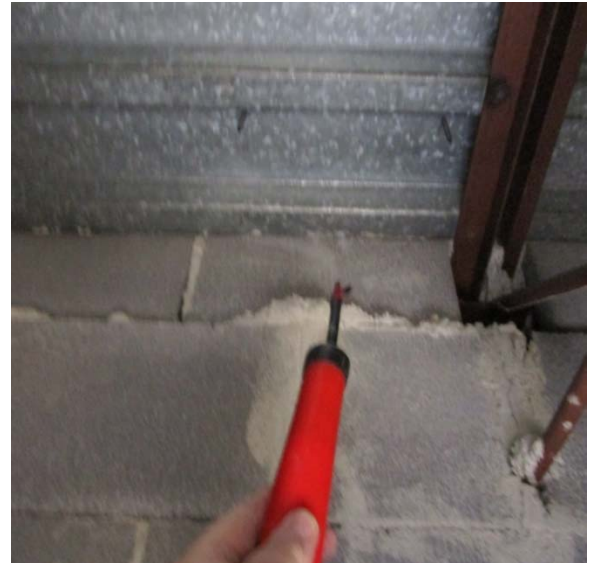
Right: Town Hall & Fire – testing indicates the roof-wall junctures are leaky throughout the additions. These junctures need to be air-sealed using 2-component, closed-cell, polyurethane spray foam.

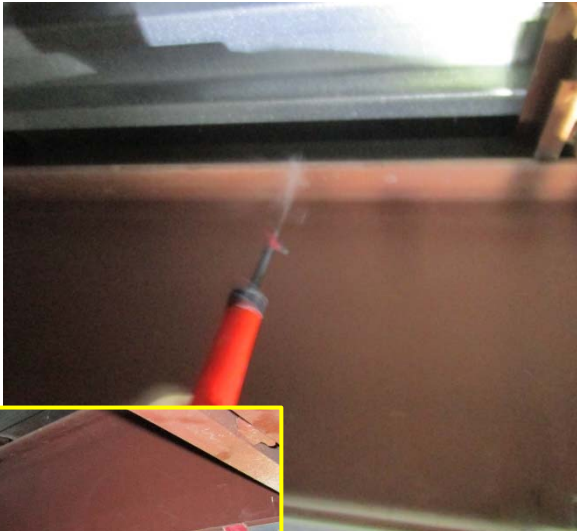
Left: Police Dept. – tracer smoke testing indicates the roof-wall junctures are very leaky. Additionally, the upper walls have batt insulation, but they lack an effective Energy Conservation, (insert); the roof-wall junctures need to be sealed with spray foam and the open framing needs to have an effective Energy Conservation material, (e.g.: rigid board insulation, with all seams sealed with 2-component, closed-cell polyurethane spray foam).

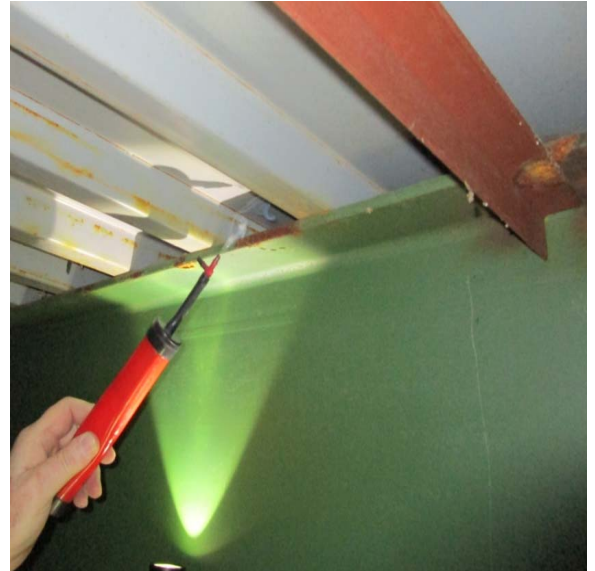
Right: Solmonese E.S. – tracer smoke testing indicates the roof-wall junctures are considerably leaky throughout both the one-story and two-story sections. Note the smoke being pulled through the junctures to the outdoors, i.e., ongoing heat loss along the entire perimeter of the school! These junctures need to be effectively air-sealed using 2-component, closed-cell, polyurethane spray foam.

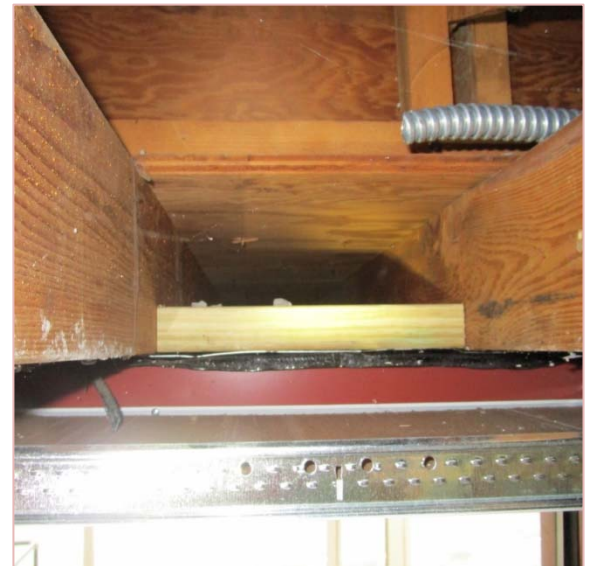
Right: Nourse E.S. – photo shows large openings in the upper walls (above the main entry), allowing for ongoing air leakage in/out of the building envelope directly to the outside; passing through the soffit/canopy. The large opening needs to be air-sealed and insulated to establish effective and aligned air and thermal barriers along the large building entry.

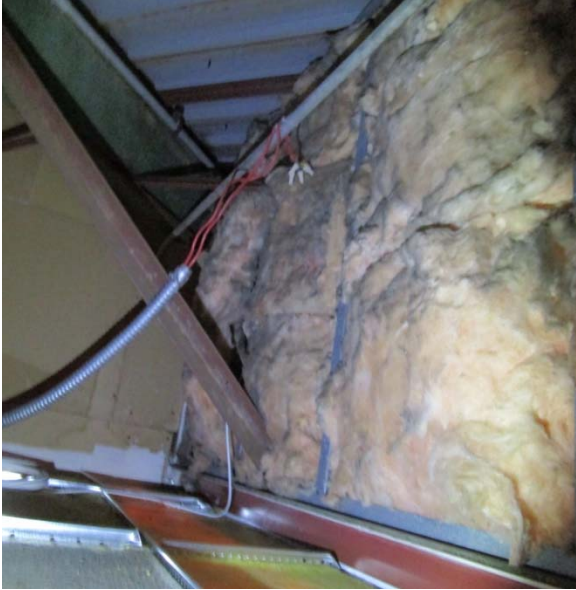
Left: Solmonese E.S. – photo shows deteriorated batt insulation “fitted” within the large opening in the exterior wall; 4’ H across the 12’ W entry door system. The ongoing air leakage in/out of the building bypasses this insulation, allowing considerable heat loss (heating season) and tremendous heat, moisture, and insects to enter the building through these opening(s) during the spring/summer seasons. These large openings represent approximately 260 square feet of voids in the exterior walls and building envelope! The openings need to be air-sealed and insulated.

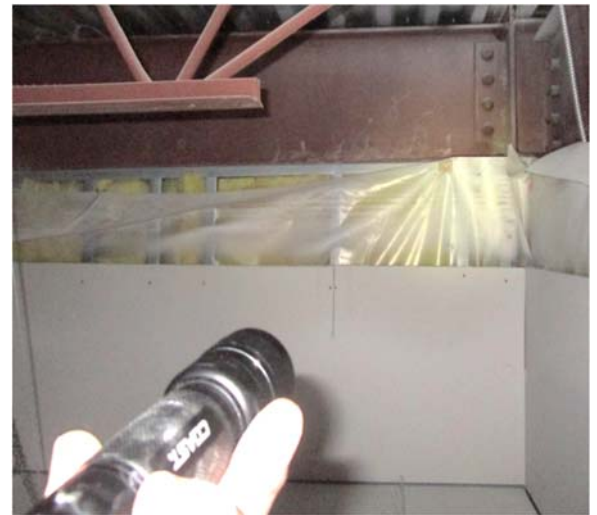
Right: Police Dept. – throughout the upper level of the two-story section, there are 6” and 2’ H voids in the Energy Conservation that need to have an effective Energy Conservation installed to assure a continuous and aligned air and thermal barrier along the top of the building envelope.

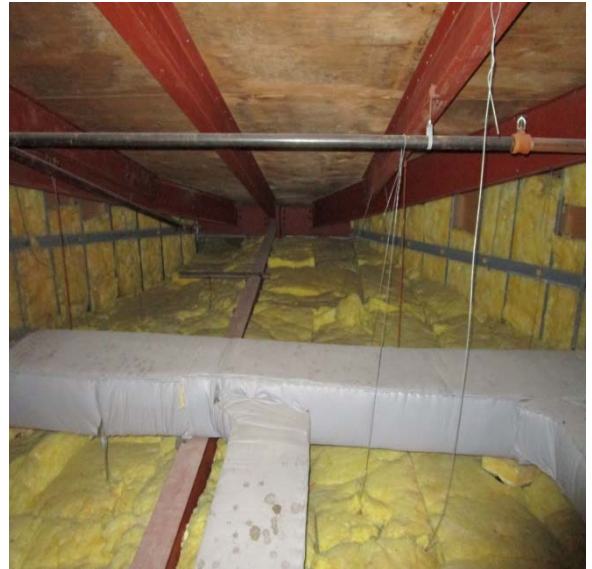
Right: Library – Across approximately 55% of the conditioned area of the main floor, there is no effective Energy Conservation in place between the conditioned spaces and attic area. In these sections, there is merely batt insulation fitted into the joist framing above the suspended ceilings. This was reported to be intentional, to temper the attic and keep the “wet” sprinkler piping from freezing. We recommend replacing the wet system with a “dry” system (in the attic) and having an effective Energy Conservation installed, affixed to the bottom of the joist framing.

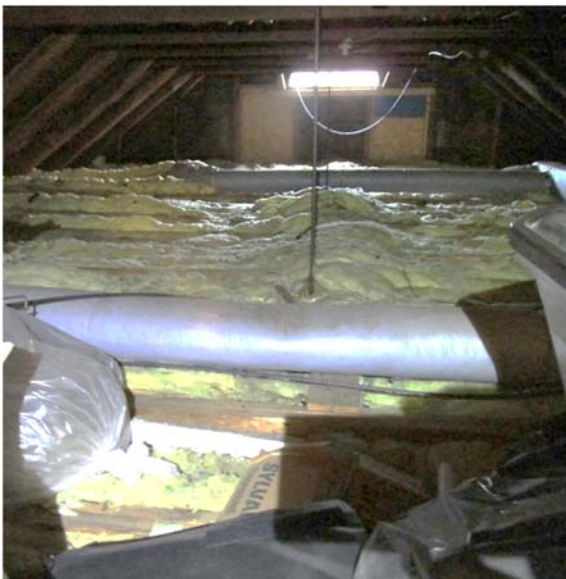
Left: Senior Center – the Energy Conservation between the conditioned spaces and attic is very leaky, with many framing chases, bypasses, and duct, pipe, top plate penetrations. Many of these are not accessible to air-seal. The attic houses HVAC equipment and the duct distribution system, and it is also used for storage of office supplies and equipment. To establish and align effective air and thermal barriers, the underside of the roof deck and the gable walls should be sealed and insulated with 2-component, closed-cell, polyurethane spray foam.

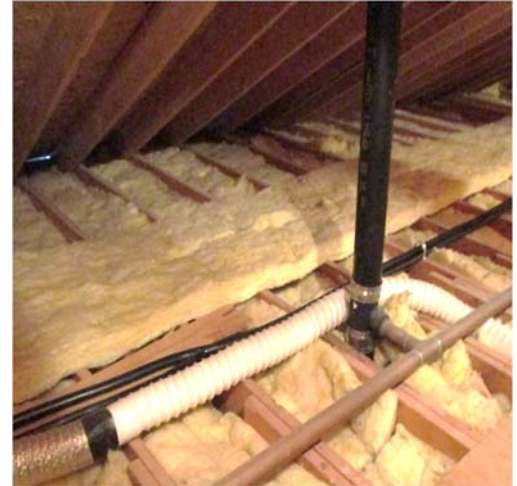
Right: Animal Control – there are several (accessible) framing chases, top plates, pipe, conduit, and exhaust fan penetrations that allow communication between the conditioned spaces below and attic, causing poor comfort and energy performance. To tighten the building envelope and establish and align effective air and thermal barriers, these air leakage paths need to be effectively air-sealed, and 6” of cellulose insulation should be installed over these R-19 batts at the attic floor.

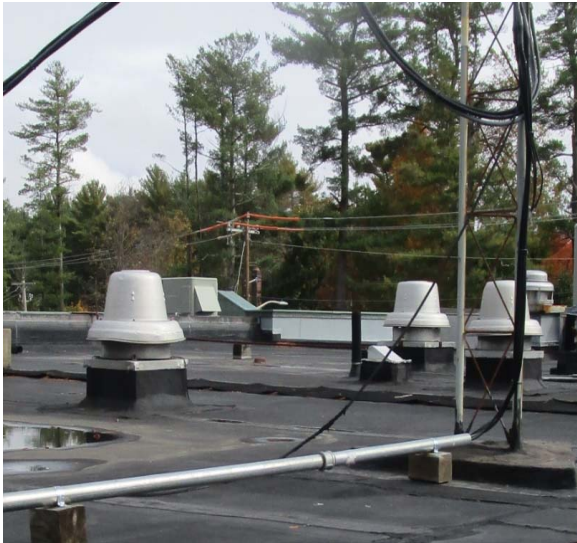
Left: Town Hall & Fire – photo shows examples of the rooftop fans at the roof decks. The tops of the large, framed chases and frame-to-curb framing are leaky, allowing communication between the conditioned spaces below, mechanical rooms, and directly with the outdoors. This is leading to poor energy performance, poor occupant comfort and IAQ, and ongoing moisture intrusion into the building systems (e.g., roof, wall, and ceiling framing and the adjoining finished surfaces), causing deterioration of these building components. These air leakage pathways need to be air-sealed.

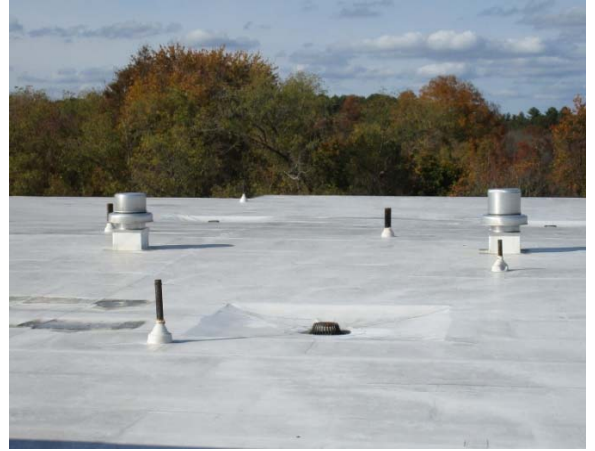
Right: Solmonese E.S. – an example of the rooftop fans on the roof of the school. The framing along the chases and the frame-to-curb junctures need to be effectively air-sealed to tighten the building envelope, improving occupant comfort & IAQ, and improve the building's overall energy performance.

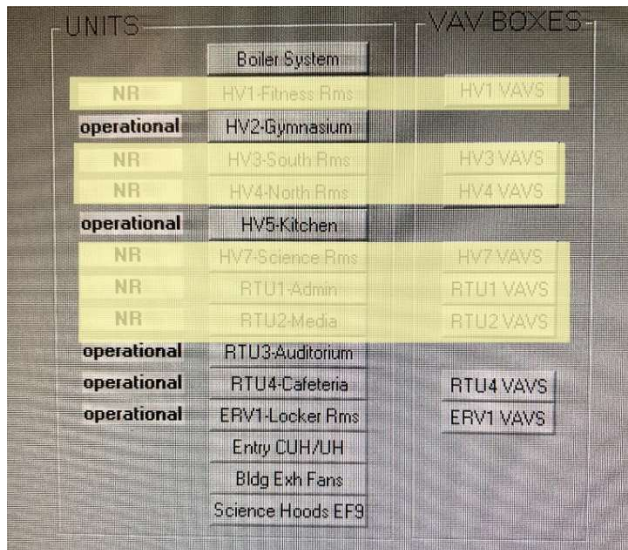
ECM-1: Advanced Energy Study

The High School building management system is no longer communicating with many of the air units throughout the school. Because of this, site and facility staff do not have control over the units. The following picture highlights the units that are no longer communicating with the BMS.
