Assawompset Pond Complex Floodwater Management Program 2020

ASSAWOMPSET POND DAM REPAIR AND REPLACEMENT

Priority Action Next Steps Summary

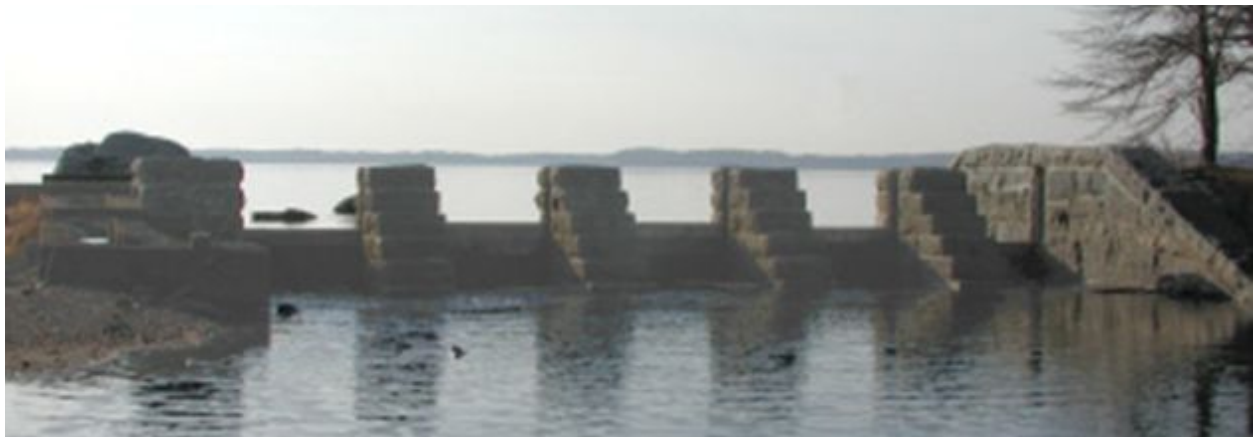
Assawompset Pond Dam

What's the problem: The dam was built in 1904 and is in somewhat poor condition. It allows for fish passage via a Denil fish ladder, which has a low but constant capacity for herring runs when pond levels are low. The dam structure itself allows migrating herring passage when pond levels are high. It is owned by the Cities of New Bedford and Taunton. The dam is a granite structure with wooden boards, and it has a 43'x 4' spillway. Due to the dam's age and design, it is dangerous to add or remove the wooden boards, making operation of the dam a liability

The dam was constructed primarily for water supply purposes (currently serving all or portions of 13 cities and towns) and not as a flood control or fish passage structure. Sand has flowed from the pond, over the dam as a result of natural circulation processes, which become exacerbated during heavy storm events, causing siltation, channel clogging, resulting in an adverse impact to the herring fishery. Sedimentation has also caused problems maintaining pond levels adequate for water supply and stream flow, as well as retaining enough storage capacity for heavy storm impacts.

What's the solution: Pending results of feasibility study and evaluation of water supply and ecological needs, repair and replace the dam in a manner that balances these competing interests and simplifies pond water level management. A reconstructed dam should allow for improved herring passage under variable water level conditions.
