Town of Norton, Massachusetts

Energy Reduction Plan

Building Envelope Inspection Report

BUILDING ENCLOSURE RETROCOMMISSIONING

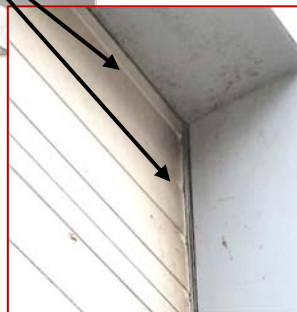
Left: Norton H.S. – photo shows the considerably deteriorated weatherstrip, with a large gap at the top as well, due to missing weatherstrip. New, appropriate weatherstrip needs to be installed along all sides of the door system.
